ENVIRONMENTAL PRIORITIES INITIATIVE
PRELIMINARY ASSESSMENT OF
LITTON BUSINESS SYSTEMS
PREPARED UNDER

TDD NO. F3-8903-56
EPA NO. PA-2427
CONTRACT NO. 68-01-7346

HAZARDOUS SITE CONTROL DIVISION
U.S. ENVIRONMENTAL PROTECTION AGENCY

SEPTEMBER 14, 1989

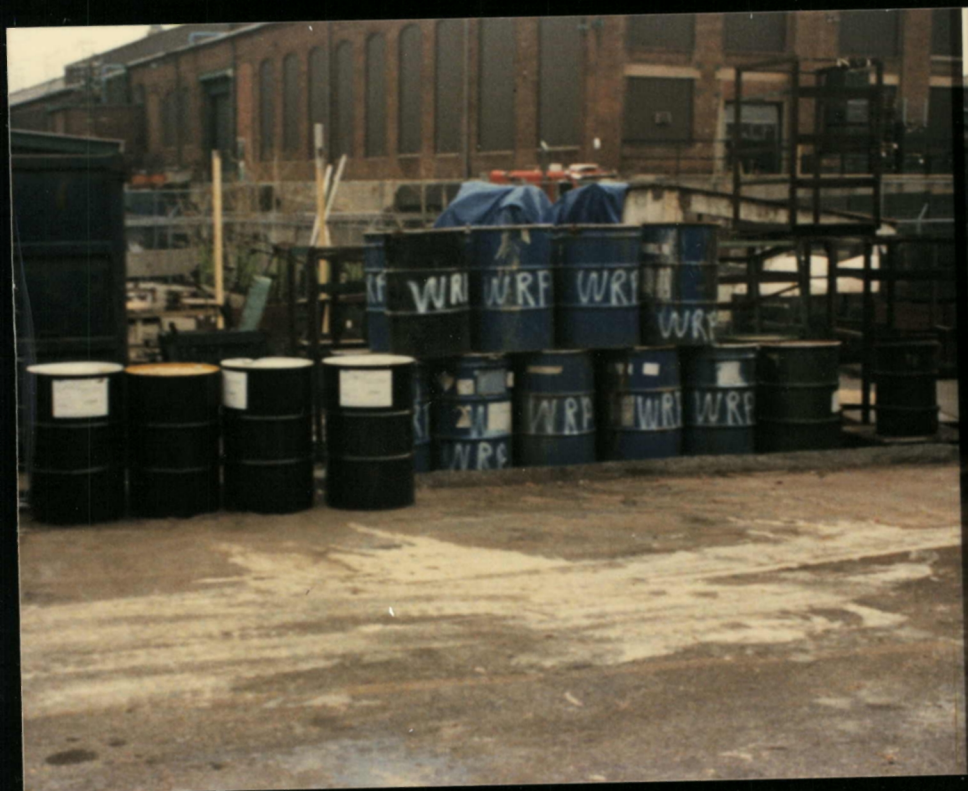
The drum storage area is a 50-square-foot area on an asphalt parking lot surrounded by a 6-inch dike. The area slopes gently to the north, toward Poor House Run. No compensation for the slope has been made in the diking. The dike was being rebuilt at the time of the site visit. No temporary containment was noted.³

Photo 2
55-Gallon Drum Waste Storage Area
Looking North

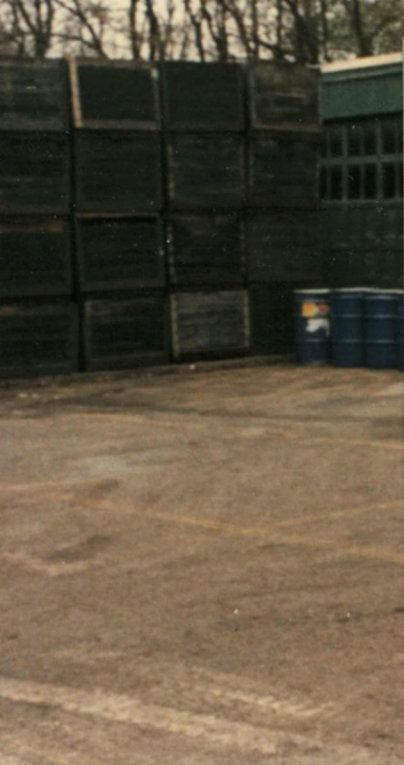
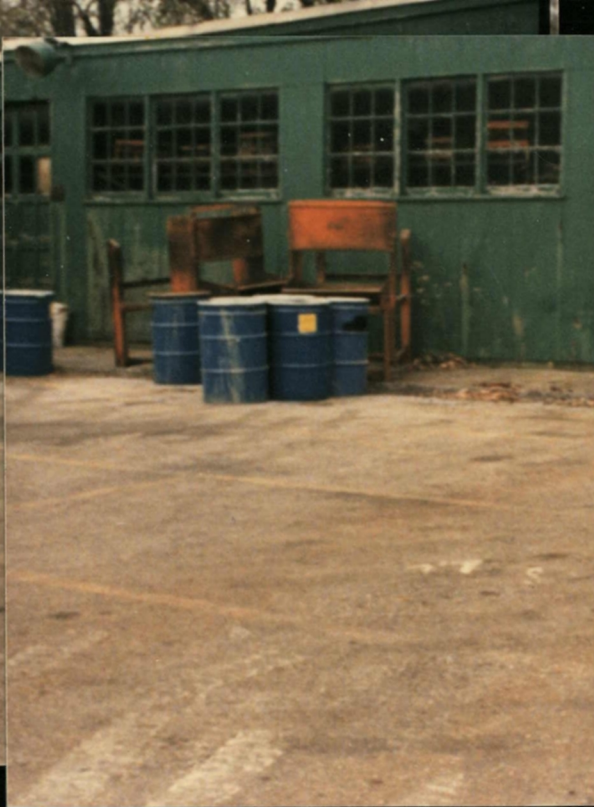
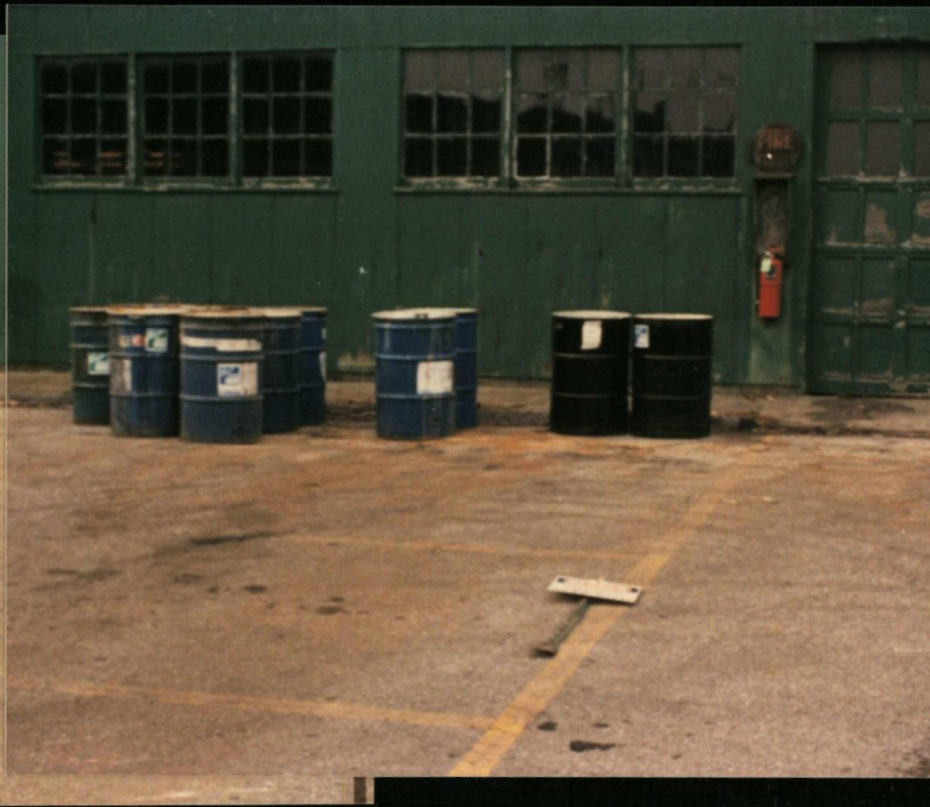
Photos 3, 4, & 5
Pan of 55-Gallon Drum Waste Storage Area
Looking South
